NATIONAL TRANSPORTATION SAFETY BOARD

TECHNICIAN'S FACTUAL REPORT

Report No. 97-64

Place : East Moriches, New York
Date : July 17, 1996
Vehicle : Boeing 747-100, N93119
NTSB No. : DCA96-M-A070
Investigator : Bob Swaim

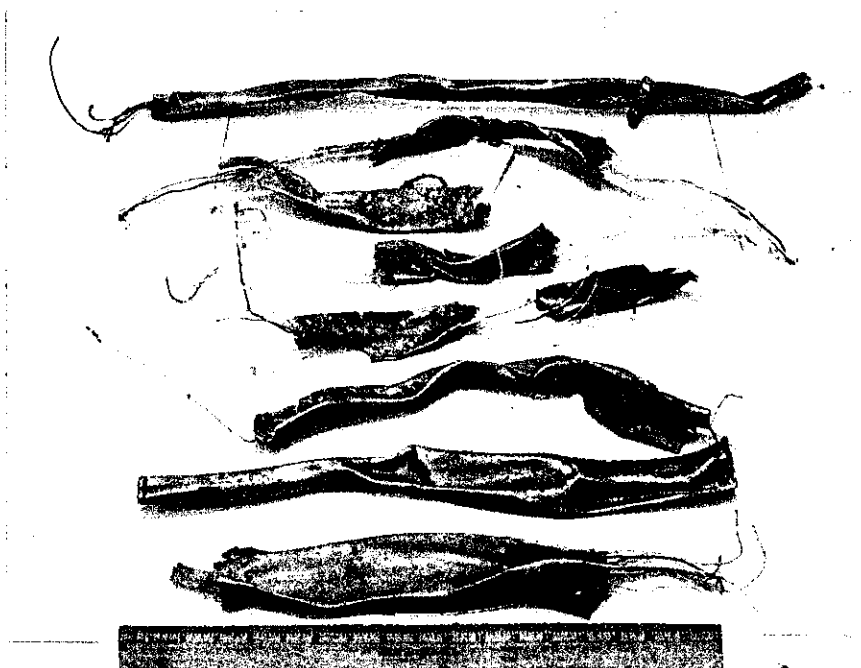
The nine sections of fuel pump conduit received for examination are shown in figure 1. The work requested was to consist of sectioning of the conduit, examination of conduit interior, examination of wiring and wire identification.

Due to the condition (crushed) of the conduit sections a continuity test was carried out between all of the wires and the conduit. This test did not indicate that any bare wire was in contact with the inside of the conduit.

Figure 1. Sections of fuel pump wiring conduit as received.
